## Impact-resistant gear unit – a new era begins with the «high» gear unit from pL LEHMANN

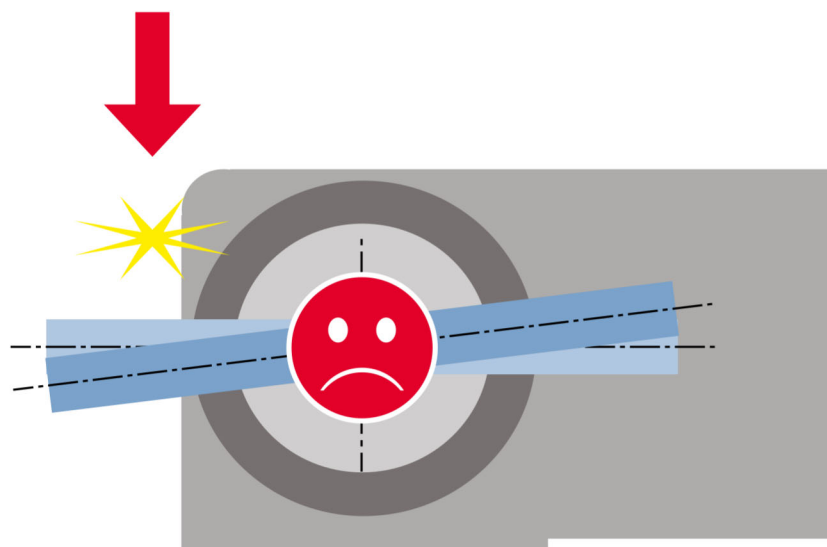
For example: The impact of a steel ball weighing 5 kg falling from a height of 60 mm at a distance of 250 mm produces a torque of 1'000 Nm on the spindle.

Most rotary tables have a bronze gear. While it can absorb severe impacts, a serious indentation cannot be prevented. Significant inaccuracy is the result at this position.

Axial or lateral collisions test a bearing's capabilities. Most rotary tables are quite capable in such situations. If the forces are applied tangentially, however, extremely high loads on the gear unit are unavoidable.
